**Jean SANS**

**Hubert SCHAFF.**

**MEMORANDUM regarding OSR 3.02.2 (OFFSHORE SPECIAL REGULATIONS).**

***§ 3.02.2 / Structural Inspection –***

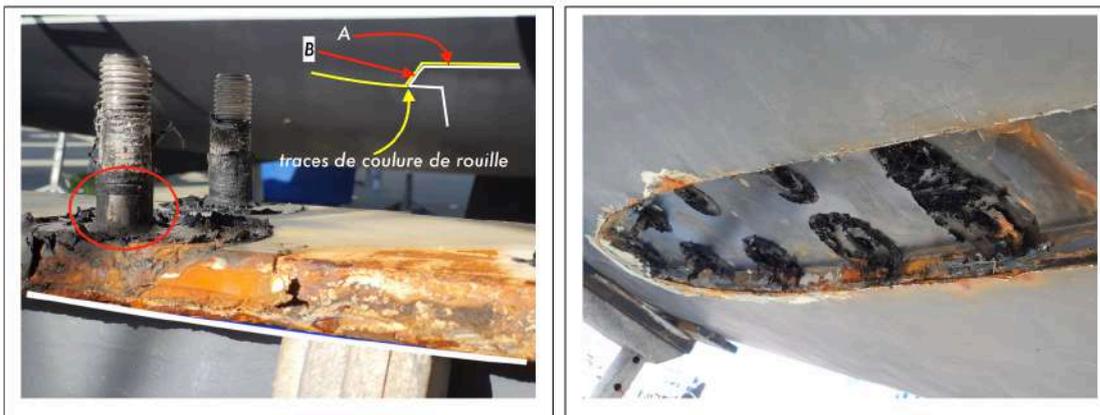
As shown in the removal operation (keel) below, the entire periphery of the sole of the keel design showed rust runs at the hull bottom. The removal operation (keel) showed that the assembly was very sound, that even the stud threads were limited in such a way as to have a smooth cylinder at the exit of the cast iron ballast (sensitive zone in fatigue). The rust runs were in fact coming from the lower edge of the cast iron sole which is impossible to protect from corrosion, even with a paint.

*Il est mécaniquement impossible d'avoir un contact surface contre surface simultanément en A et B car la géométrie est surabondante. On privilégie l'appui sur A car c'est la surface fonctionnelle, la surface B est liée à la hauteur d'implantation du goujon ou de la tête de la vis, suivant le type d'assemblage. Son encastrement dans l'épaisseur de la coque est optionnel, la semelle pourrait très bien être entièrement en surépaisseur sur la coque du bateau.*

This removal of the keel prescribed by the OSRs appears to be a precautionary principle. The decision to remove at the time of the inspection (rust on the periphery of the keel sole) will remain a very subjective decision.

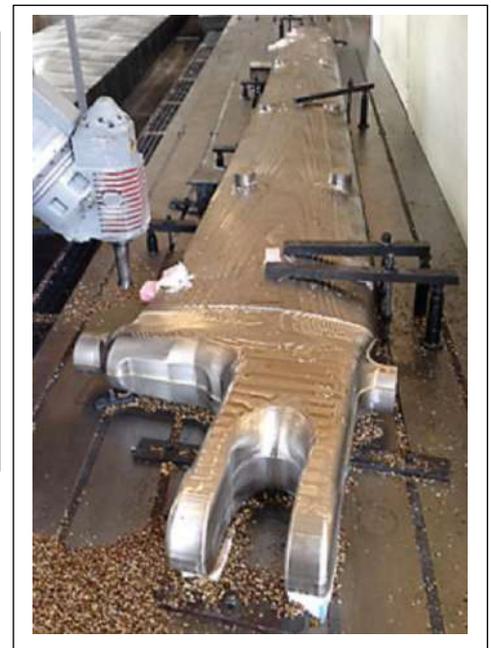
When we see (opposite) a canting keel sail during machining operations, we can reasonably question the validity of the findings of a visual inspection when the keel is assembled on the boat.

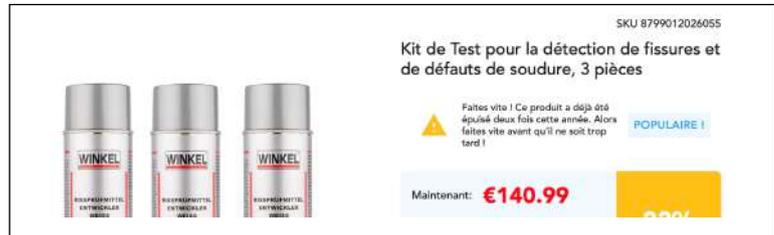
Thus the inspection will focus on the search for fatigue cracks in the area of the rudder stock exit at the bearing. This inspection requires that the rudder stock be "lowered" (after disconnecting the control systems) when the boat is dry, without removing the entire rudder from the boat. The upper bearing area may be excluded from this inspection.

The most effective basic technique is local dye penetrant testing of the rudder shaft in the area near the hull bearing.
